# El Camino Real Complete Streets Study

San Mateo County Bicycle & Pedestrian Advisory Committee

August 15, 2024

Phase 1 Summary

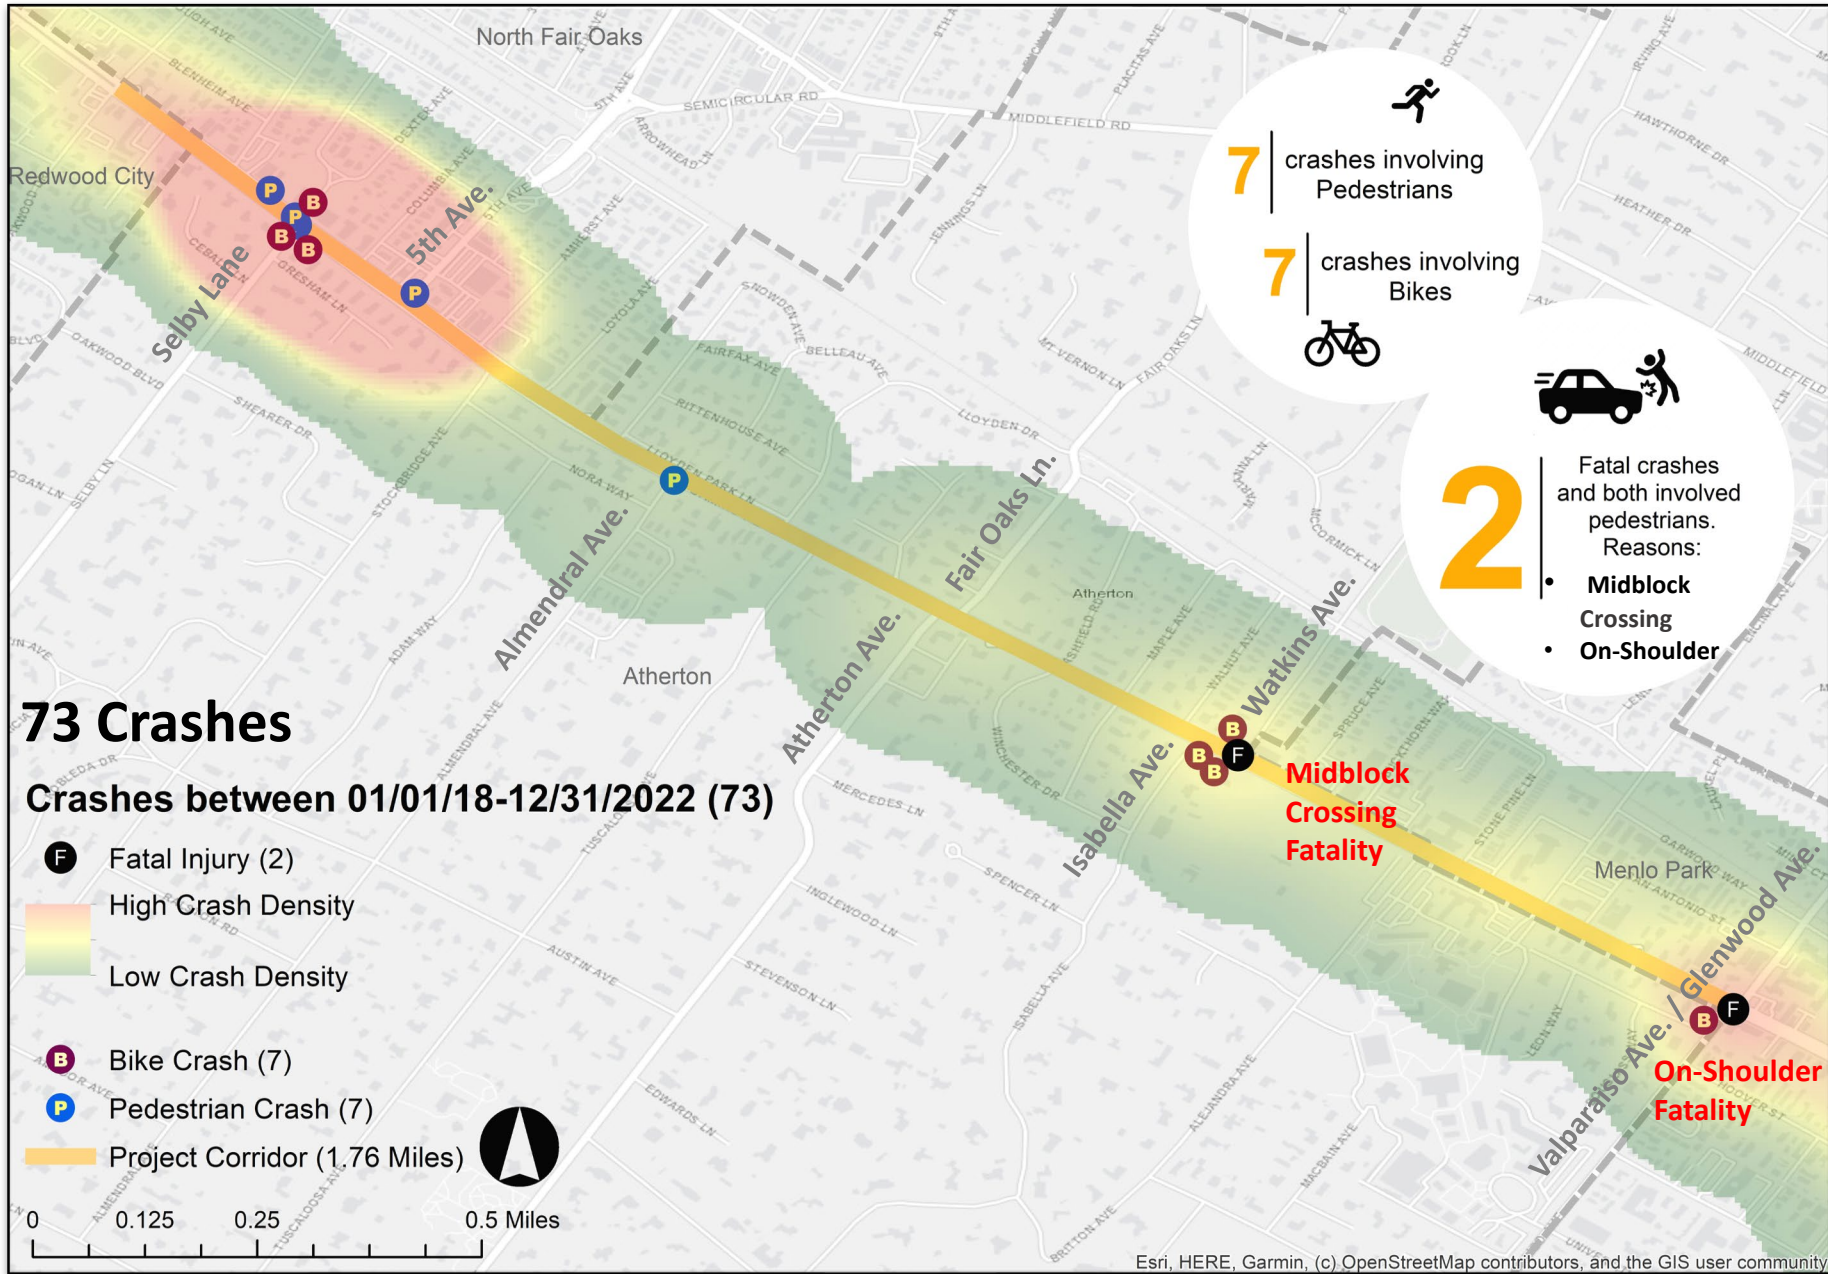
# Crash Analysis

Data:  
January 1, 2018, to  
December 31, 2022

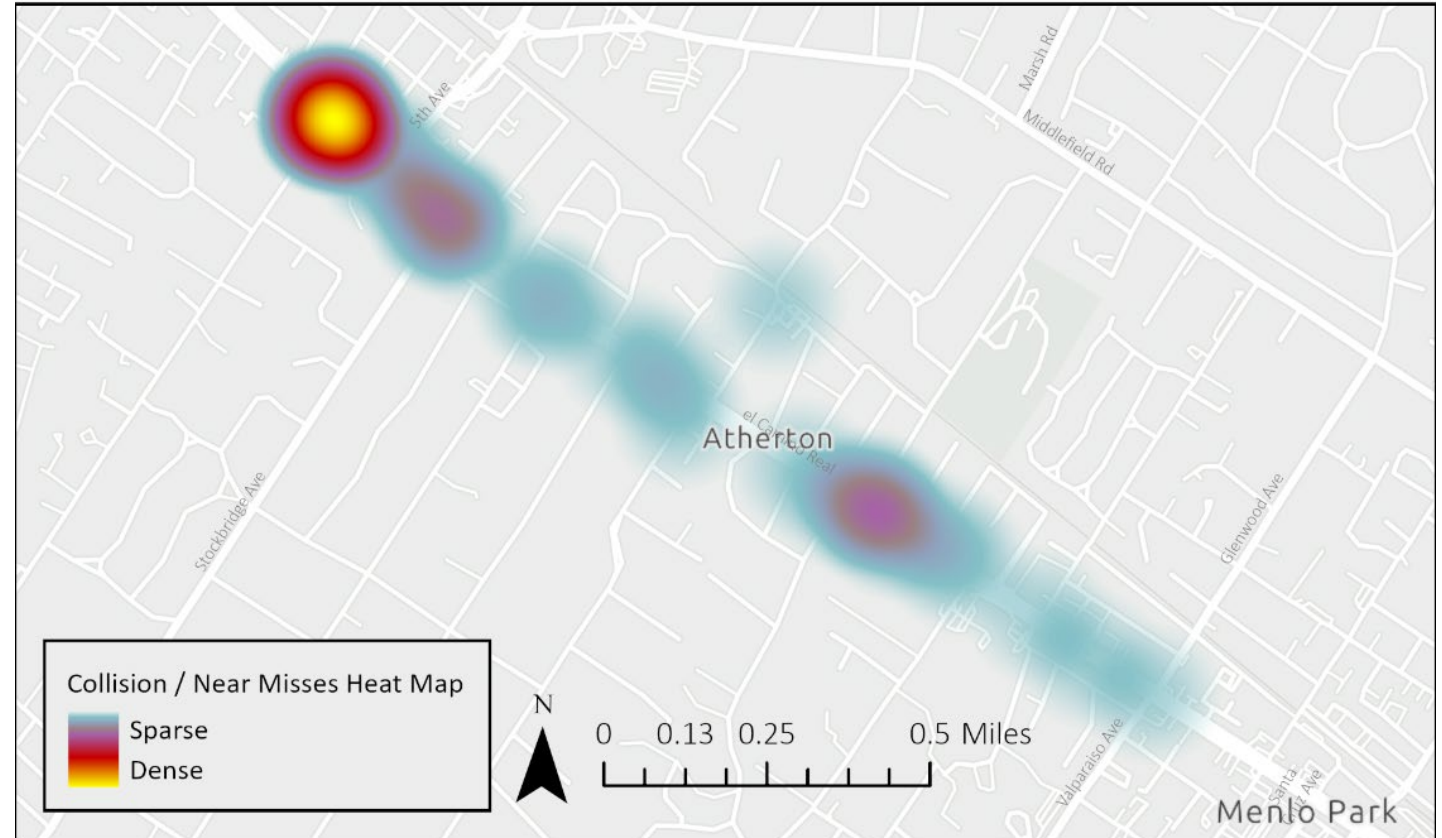
## Atherton Phase 1 Survey Responses: Collisions & Near Misses

Markers on the map were combined with data from the survey to map collisions or near misses as reported by the public.
